SURVEY REPORT # 4038

Date: April 10, 2007

Vessel Name: "TANGO"

Purpose of Survey: Condition and value for pre-purchase.

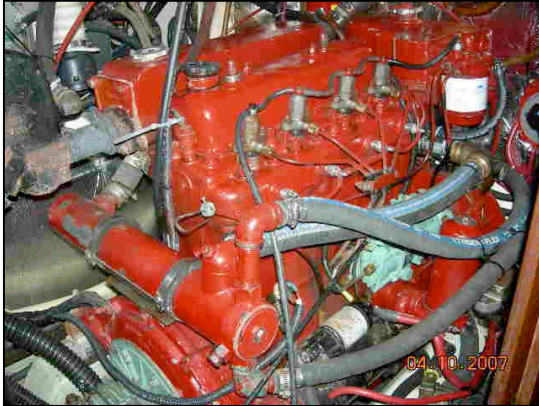
View of engine (stbd side)

- Comments:** Engine was only run briefly during survey. It was reportedly re-built in 1999/2000. External condition is good, free of grime and corrosion, paint in good condition. Oil and coolant levels are normal. A minor amount of fuel was noted in the drip pan. (Note)
- Type:** Diesel, 4-stroke, naturally aspirated
- Hours:** 2388 by meter
- Manufacturer:** WESTERBEKE
- Model:** W60
- Serial Number:** 25V 527BD 4757
- #Cylinders:** 4 in-line
- Horse Power:** 53 HP @ 2500 rpm
- Year/Year rebuilt:** Assumed original / rebuilt 2000
- Cooling System:** Fresh water heat exchanger
- Alarms:** Yes (Note)
- Gauges:** Standard panel in cockpit
- Exhaust Type/Line:** Wet / Reinforced hose
- Silencer:** Can type FRP waterlift
- Reduction Gear/Ratio:** Short Profile Sailing Gear / 2:1

10. Suggest using absorbent pad(s) to remove all spillage at drip pan and monitor any future leakage. Fuel leak appears to come from manual priming pump.
11. A single clamp was noted on the exhaust hose at the connection with exhaust elbow, waterlift muffler, in-line coupling and at the transom fitting: double clamp as per ABYC P-1.7.1.10.1 if fitting barb length allows.
12. Replace rusty hose clamps at shaft log water injection nipple

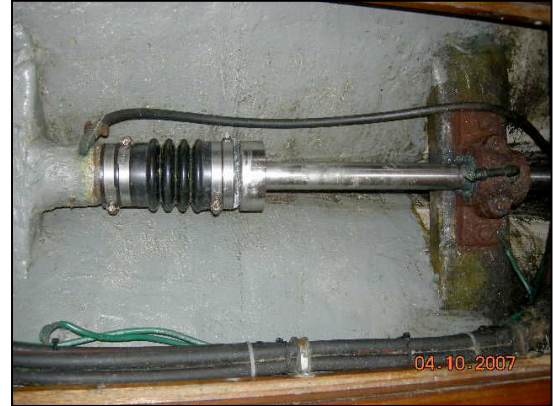
Dripless shaft seal & pillow block bearing

Belts/Hoses: Appear good
Shaft: 1 1/2" stainless steel
Stuffing Box: PSS dripless shaft seal (Note)
Strut/Bearing: Single leg Bronze / Cutlass – good
Propeller: 3-blade fixed bronze 17" RH 12"
Controls: Dual lever at pedestal - good
Eng. Beds/Mounts: HD stringers / Appear good

13. Shaft and rudder stuffing glands should be checked monthly, thru-hull valves should be operated at the same time to maintain operating condition. They all should be serviced and zincs replaced as necessary at each haul-out.

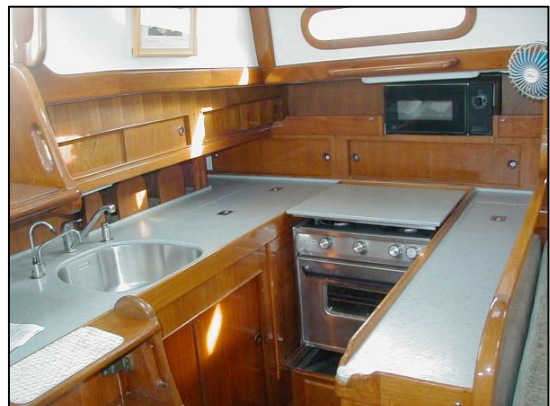
View of galley

Comments: Practical layout and good storage. New custom Corian countertops. Very good condition.

18. Secure third CNG cylinder.

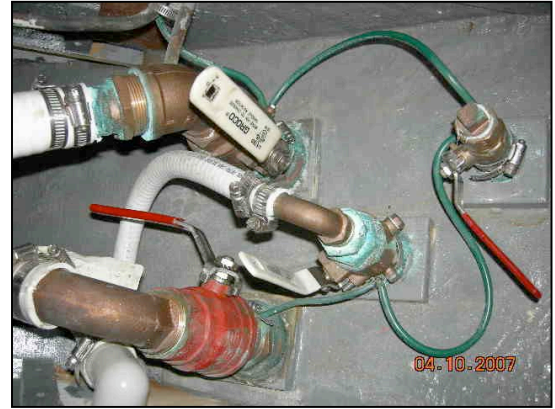
Comments: Good overall. Original stainless steel have been abandoned or cut out for installation of flexible tanks. Most of the sea valves have been replaced.

New sea valves, bonded

15. The water system could not be tested as there is a broken fitting and disconnected hose on the cold of galley sink faucet: repair as necessary.
16. Clean icebox in-line strainer (under galley sink)
17. The two sea valves located in engine space (port side) are difficult to access, operate and service; they could not be operated at time of survey. Recommend re-locating in more accessible position.
