SURVEY REPORT # 4038

Date: April 10, 2007

Vessel Name: "TANGO"

Purpose of Survey: Condition and value for pre-purchase.

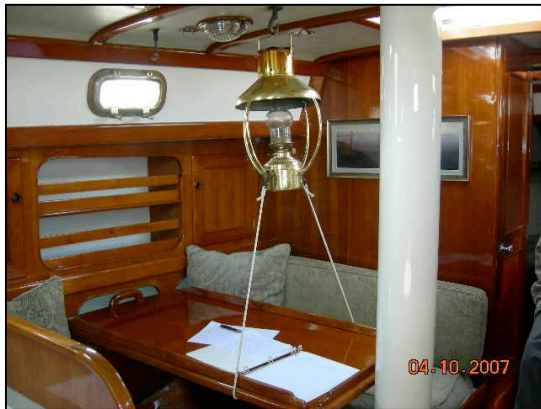
View of dinette

- The superstructure is in very good condition - All brightwork has been refinished.
 - The interior is well appointed, clean and uncluttered. Good quality wood joinery, recently re-varnished, new upholstery throughout – very good condition.
